Use Attainability Analysis

WBID 0167 Brushy Creek

Submitted by
Pickett Ray and Silver

To
Missouri Department of Natural Resources
Water Protection Program

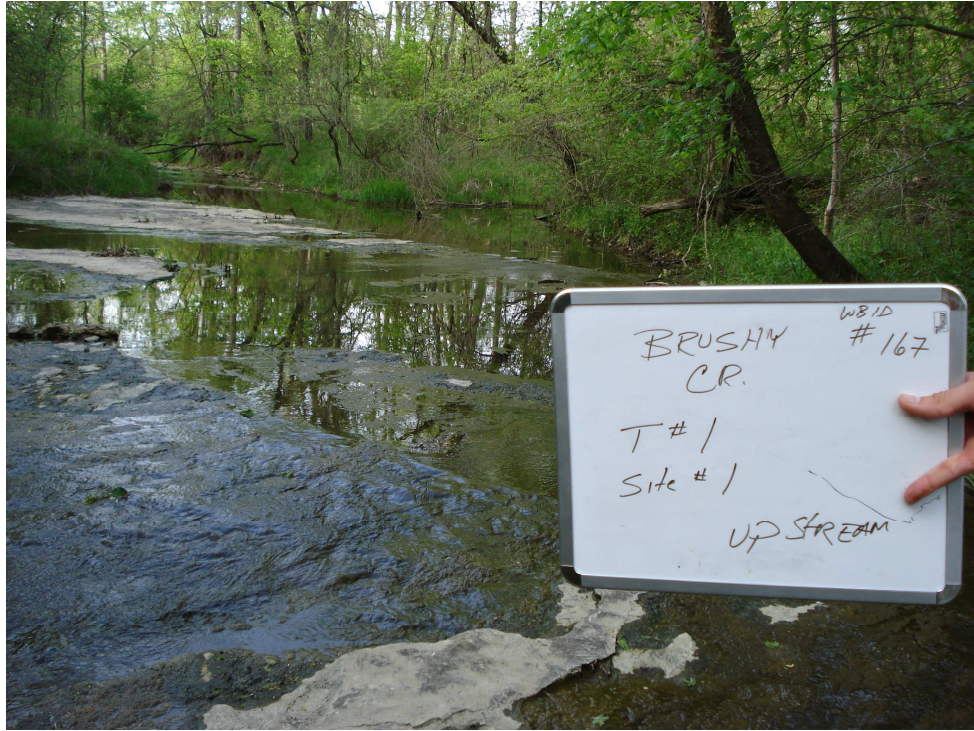
1. Upstream Site 1, Transect 1

| Channel Feature | Distance from access (m) | Width (m) | Length (m) | Median Depth (m) | Max. Depth (m) |
|---|---|---|---|---|---|
| RUN | 60 | 7.0 | 30 | 0.2 | 0.3 |

| - % Cobble | - % Gravel | - % Sand | - % Silt | - % Mud/Clay | 100 % Bedrock |

Algae all over substrate

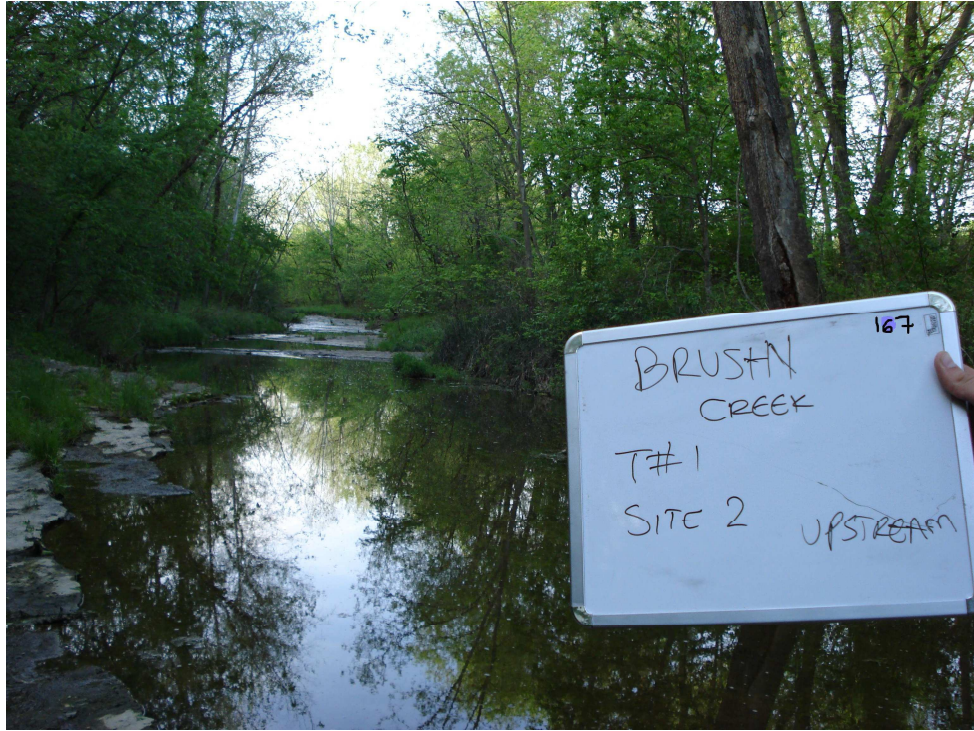
3. Upstream Site 2, Transect 1

| Channel Feature | Distance from access (m) | Width (m) | Length (m) | Median Depth (m) | Max. Depth (m) |
|---|---|---|---|---|---|
| RUN | 160 | 5.0 | 20 | 0.25 | 0.3 |

| 25 % Cobble | - % Gravel | - % Sand | - % Silt | - % Mud/Clay | 75 % Bedrock |

Some algae on substrate

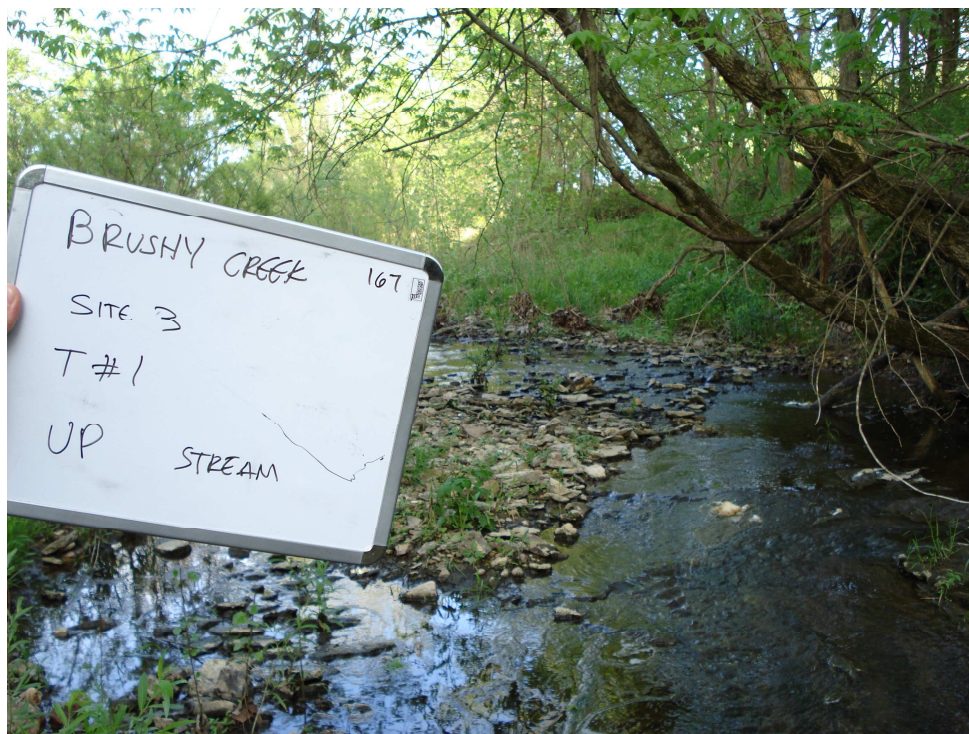
5. Upstream Site 3, Transect 1

| Comments: Nothing but grassy, pasture like conditions | | | | |
